# GREEN OASIS PLANTSCAPES, LLC FIRE TEST REPORT

ASTM E84 TESTING ON MOSS WALL

104526701SAT-001

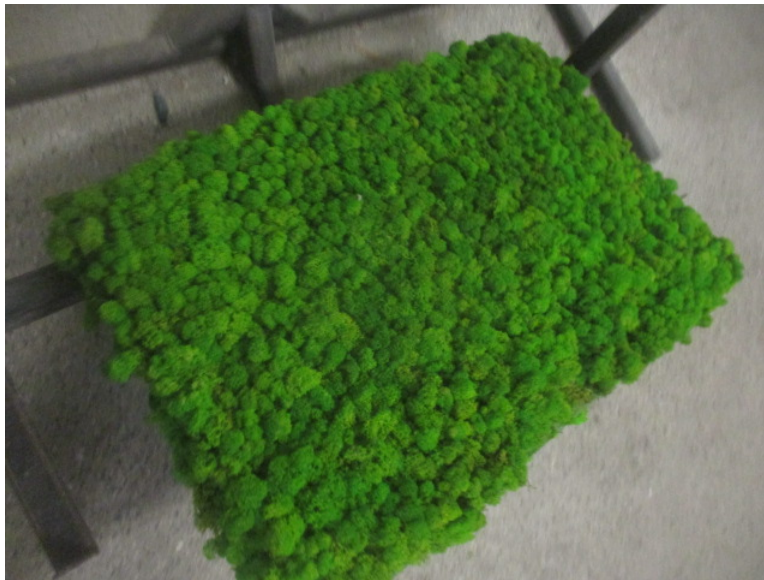
**Photo No. 1**  
**Exposed Surface of the Test Specimen (Pre-test)**

<b>MANUFACTURER*</b>	Green Oasis Plantscapes, LLC
<b>SPECIMEN DESCRIPTION*</b>	Reindeer Moss with Felt Substrate
<b>CONDITIONING TIME</b>	14 days
<b>SPECIMEN LENGTH</b>	24 ft. (Eight 3 ft. long artificial foliage panels)
<b>SPECIMEN WIDTH</b>	24 in.
<b>THICKNESS</b>	2.5 in.
<b>TOTAL WEIGHT</b>	52 lbs.
<b>COLOR</b>	Green
<b>ADHESIVE/COVERAGE RATE</b>	N/A
<b>SIDE TO FLAME*</b>	Finished Side
<b>SUPPORT USED*</b>	Rods and Wire
<b>MOUNTING METHOD</b>	Standard
<b>SUBSTRATE USED*</b>	None
<b>CEMENT BOARD</b>	1/4 in. thick fiber cement board was placed on top of the sample.

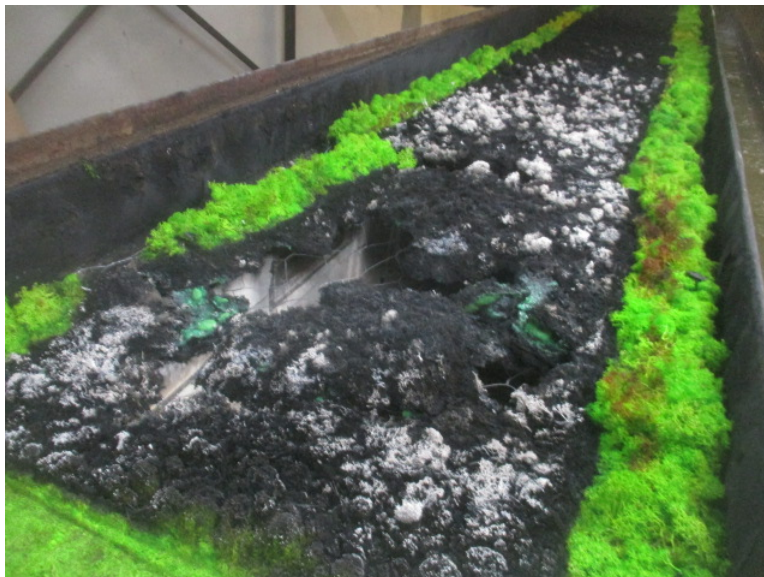
**Photo No. 4**

**Exposed Surface of the Test Specimen (Post-test)**

<b>TEST OBSERVATIONS</b>	
Transient Ignition Time	0:30
Ignition Time	6:10
After Flame	0:38
Observations After the Test:	
0 – 3 ft.	The specimen was mostly consumed and heavily charred.
3 – 6 ft.	The specimen was heavily charred and bleached.
6 – 11 ft.	The specimen was heavily charred.
11 – 21 ft.	The specimen was charred.
21 – 24 ft.	The specimen was lightly charred.

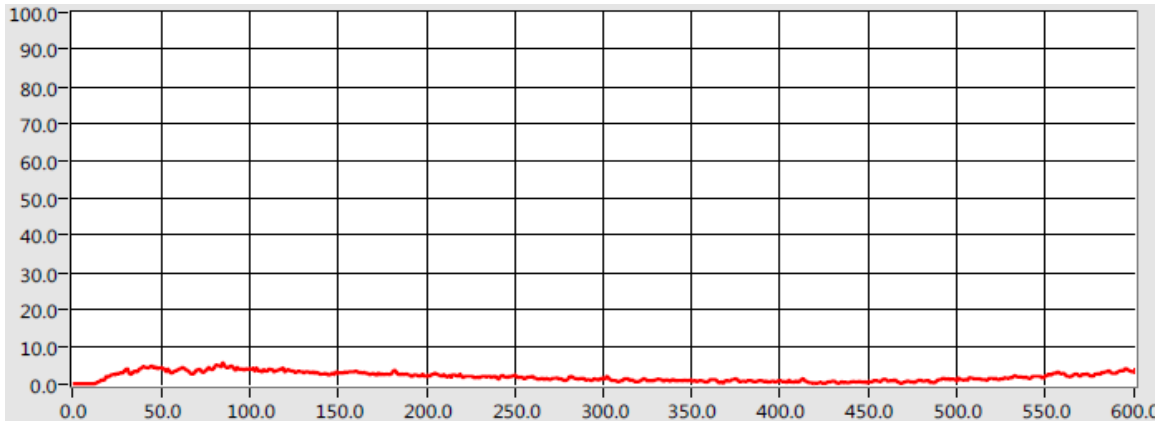
Graph No. 2 - Light Obscuration Versus Time
